GLH Home Inspections, LLC

1 Dreamhome Way
Norwalk, OH 44857

Prepared for: *Joe Homeowner*

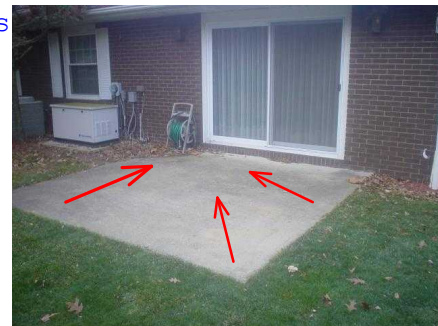
1. *Satisfactory* Driveway: *Concrete*
2. *Satisfactory* Walks: *Concrete*
3. *Satisfactory* Porch: *Concrete*
4. *Marginal* Patio: *Concrete* The patio in rear has settled towards the foundation causing a negative slope into the foundation. Recommend repair.

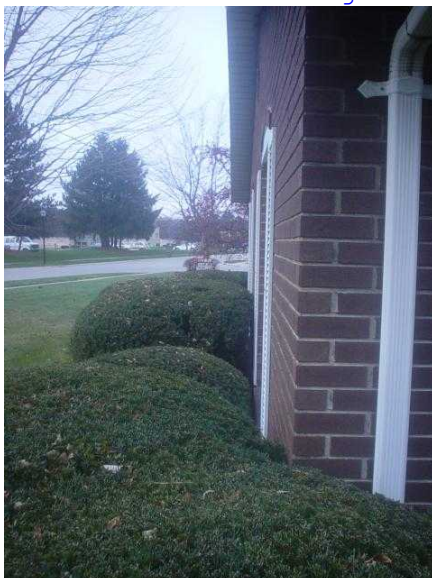
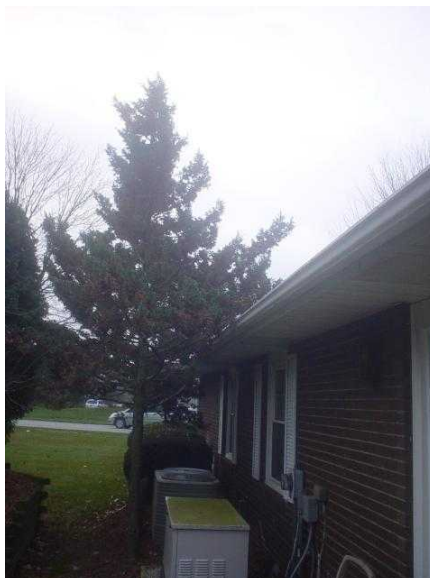
5. *Satisfactory* Grading: *Moderate slope Flat or nearly flat areas near foundation. Water might pond in flat or nearly flat areas. Condition can undermine the structure foundation and cause subsequent damage, including settling cracks in the walls and ceilings. Recommend monitoring grading during rainfall and further evaluation if water ponding or other problems detected*
6. *Marginal* Vegetation: *Shrubs/Trees Vegetation was too close to, touching, or growing on siding. Condition can promote excessive damage and deterioration by movement of branches, root growth and/or attachment, and moisture retention, and can promote pest infestations. Recommend having licensed landscape professional trim or remove vegetation from affected areas and/or regular homeowner monitoring and maintenance, as Client desires Tree limbs over hang the roof and should be cut back*

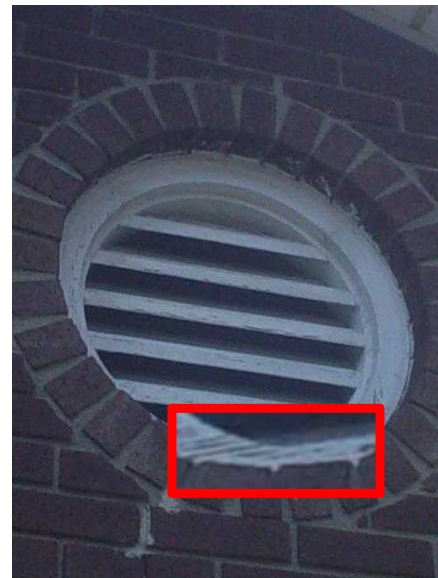
1. *Satisfactory* Type: *Brick veneer*
2. *Marginal* Trim: *Aluminum/wood* Areas of peeling paint and/or bare wood noted. Recommend repair/repainting.

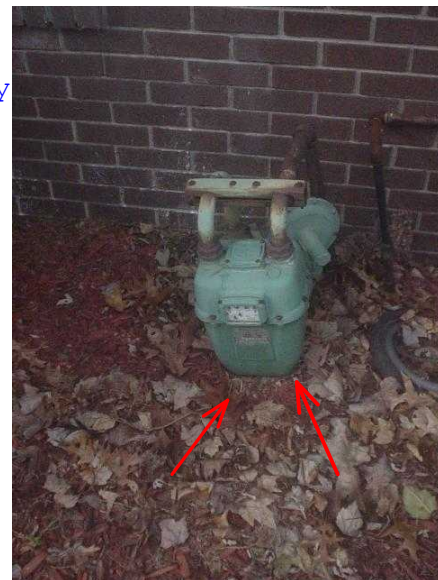
13. *Satisfactory* Hose Bibs: *Operating at time of inspection*
14. *Marginal* Gas Meter: *Exterior surface mount at side of home Gas meter casing was partially below grade. Condition can result in moisture damage to the casing, possibly resulting in leaks. Recommend modifying grade to ensure that gas meter casing sits above ground*

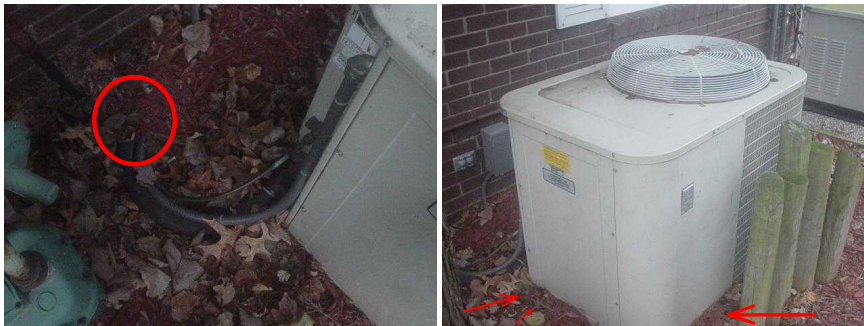
9. *Marginal* Refrigerant Lines: *Serviceable condition* Lines covered by landscaping. Recommend uncovering lines so condition can be monitored and avoid accelerated deterioration.

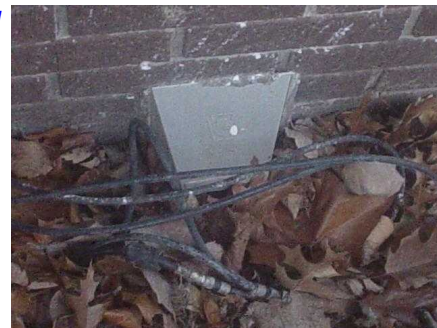
1. *Satisfactory* Ceiling: *Wood*
 2. *Satisfactory* Walls: *Paint*
 3. *Satisfactory* Floor: *Carpet*
 4. *Satisfactory* Doors: *Bi-fold*
 5. *Satisfactory* Electrical: *110 VAC/220 VAC*
 6. *Satisfactory* Washer Hose Bib: *Operating*
 7. *Satisfactory* Washer and Dryer Electrical: *110 VAC*
 8. *Marginal* Dryer Vent: *Through wall* Dryer vent hood at exterior was blocked by debris. The flue and vent hood quite often become clogged with lint. Lint is flammable, and a build-up of lint can affect the drying efficiency of the dryer and could result in a flue fire or cause the dryer to overheat, possibly resulting in a dryer fire. Recommend having any blockage removed and regular homeowner monitoring and maintenance.
 9. *Not Present* Dryer Gas Line:
 10. *Satisfactory* Washer Drain: *Wall mounted drain*
 11. *Not Present* Floor Drain:

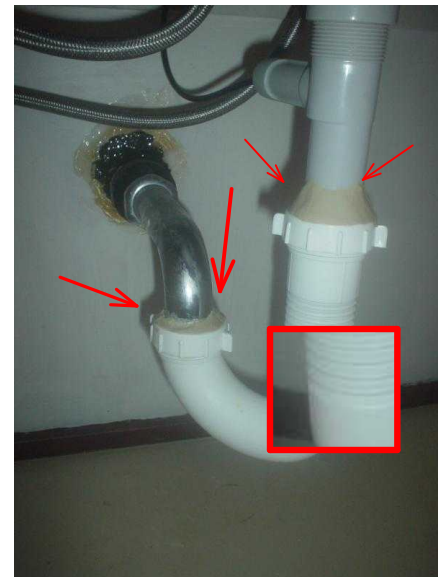
Sink/Basin: Porcelain *Leak noted under sink. Unable to verify source. Recommend further evaluation by qualified plumber and repair as needed*
Non typical plumbing methods used. Tail pipe and drain line appear to be 1 1/4" and trap 1 1/2". Recommend evaluation by a qualified plumber.

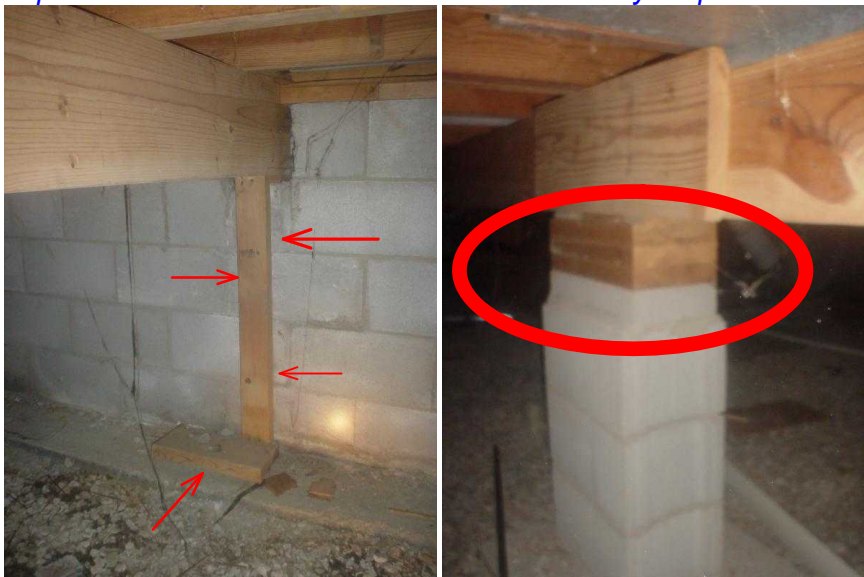
1. *Marginal* Structure Type: *Masonry* *Additional support added to structure. Inspectors have no knowledge if additional support was appropriate designed and engineered for its long-term ability to maintain support. Recommend further evaluation by a structural engineer. The floor structure had a number of non-standard beam and joist supports, including additional bracing and wood shims to level floor or prevent floor squeaks. Since these methods are neither standard nor proven construction practices, their long-term ability to maintain support is unpredictable. Recommend further evaluation by a qualified contractor.*

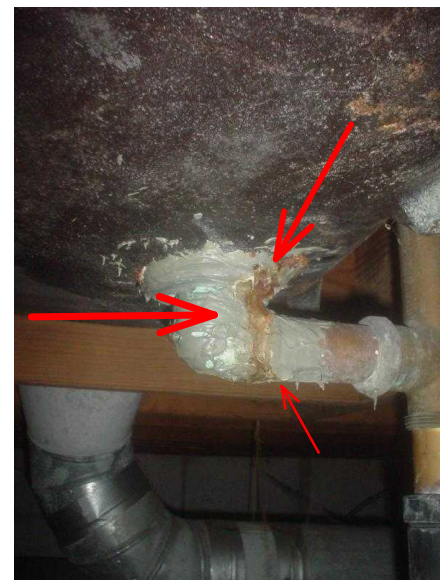
1. *Satisfactory* Service Line: *Copper*
2. *Satisfactory* Main Water Shutoff: *Crawl Space*
3. *Satisfactory* Water Lines: *Copper*
4. *Poor* Drain Pipes: *PVC* *Leaking drain pipe noted under master bath tub drain. Recommend repair.*

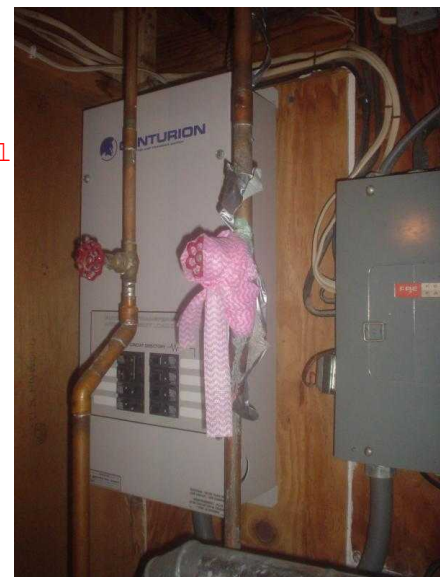
7. *Marginal* Water Heater Operation: *Functional at time of inspection* *Water heater has exceeded design life. Excessive corrosion on water shutoff valve. Maintenance concern. Leaks could develop at any time and valves may not work properly or may fail when used. Recommend further evaluation by licensed plumbing professional. Burners and burner chamber were rusty or excessive rust flakes in burner chamber. Condition can indicate poor performance, including incomplete combustion and excessive production of carbon monoxide. Recommend further evaluation by licensed plumber.*

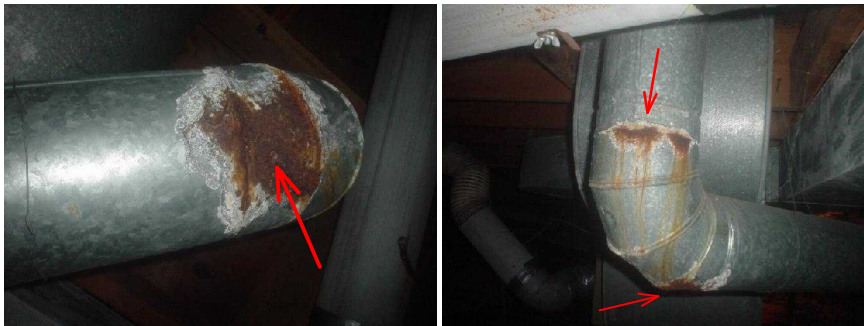
11. *Poor* Flue Pipe: *Single wall* Rust holes noted. Safety Hazard. Recommend repair/replace.

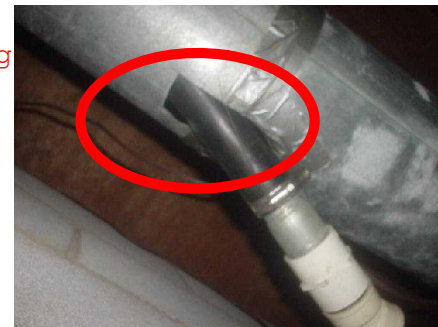
11. *Poor* Distribution: *Metal duct* Non-typical routing of duct work. Plumbing drain line appears to be entering duct work in crawl space. Recommend evaluation by qualified HVAC technician and/or plumber.

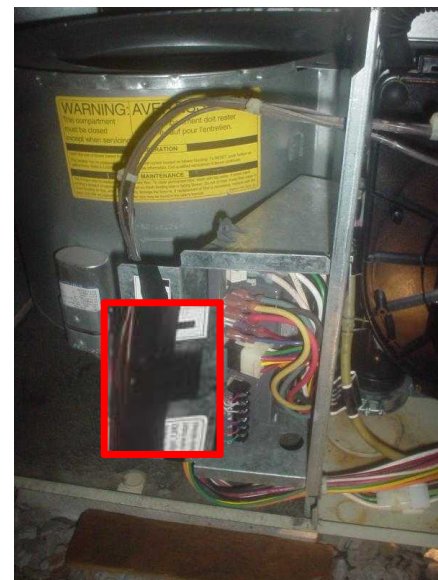
12. *Satisfactory* Flue Pipe: *PVC*
13. *Poor* Controls: Normal safety and operating controls observed. *Safety kill switch has been taped on. Recommend evaluation by an HVAC technician to determine reason and repair..*

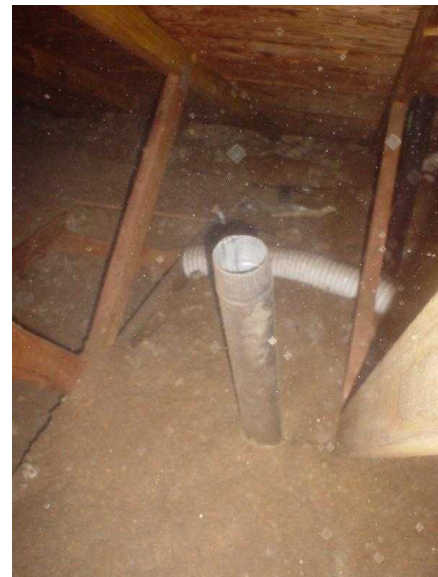
11. *Poor* Bathroom Fan Venting: *Electric fan Bathroom exhaust fan flue terminated in attic. Maintenance concern. Moisture should be vented to the exterior to prevent moisture damage to structural framing. Recommend having flue extended to exterior of attic*
