Carpenter Bees

HYG-2074-06

Susan C. Jones

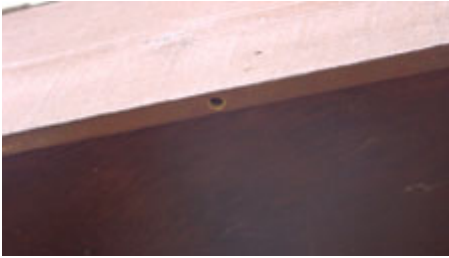
Figure 2. Carpenter bee entrance hole in fascia.

The carpenter bee entrance hole in wood may not necessarily be in an exposed area. For example, the inner lip of fascia boards is a common site of attack. Nail holes, exposed saw cuts, and unpainted wood are attractive sites for the bees to start their excavations.

Carpenter bees create a nuisance by excavating round entry holes in wood (Figure 2) and depositing yellowish to brownish streaks of excrement and pollen on surfaces below entry holes (Figure 3). They also produce coarse sawdust from their borings. The carpenter bee gallery system is confined within the wood (Figure 4) and hence is not visible.

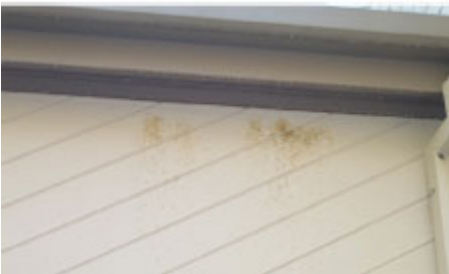
Figure 3. Carpenter bee staining on siding below the fascia.

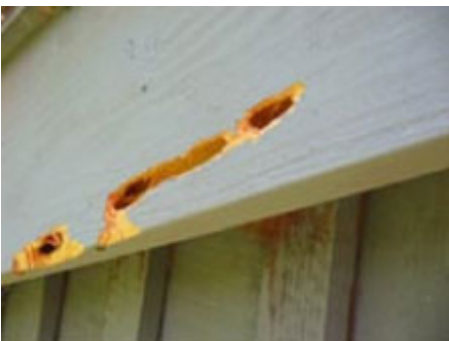
Figure 4. Carpenter bee gallery exposed in wood.

Carpenter bee damage to wood initially is minor, and carpenter bees seldom cause consequential structural damage. However, their repeated colonization of the same wood can eventually cause considerable wood damage. Carpenter bees preferentially refurbish and enlarge an existing tunnel instead of boring a new one, and a gallery can extend for 10 feet if used by many carpenter bees over the years.
