Knob & Tube Wiring by Douglas Hansen

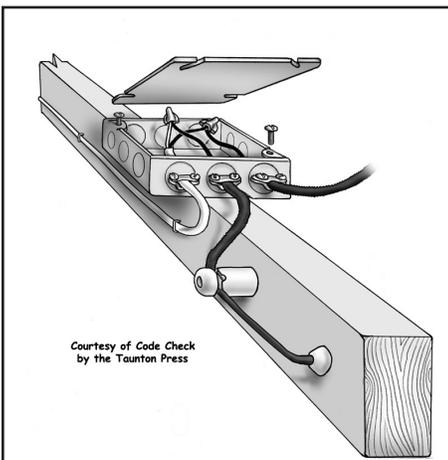
Figure 3 — Proper Splicing Method for Extensions

Splices from knob & tube to another wiring method are often done incorrectly. Even though the original knob & tube splices are exposed, splices to another wiring method must be contained in boxes. Because wires entering a box must

have at least 6 inches of free conductor in the box, a single box is seldom sufficient; two boxes are usually needed.

An A-head device with a bushing is needed at the end of an AC cable before splicing to knob and tube, and loom should cover each con-

ductor of the knob and tube between the last knob and the device. The conductors from the AC cable should only extend as far as necessary to have an open splice into the knob & tube. Due to the lack of availability of older loom, some jurisdictions allow a piece of Romex® sheathing as a substitute for loom. In most instances, splices are improper and should be avoided. New circuits are usually a better choice instead of extending the older wiring system.

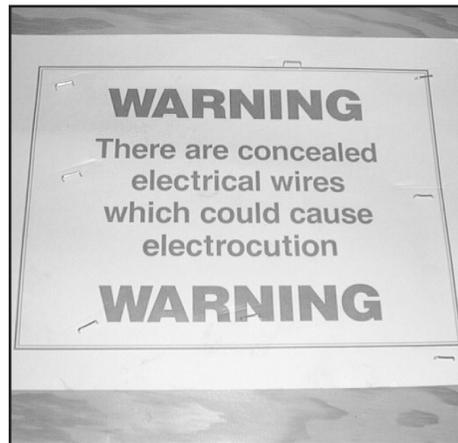
Figure 4 — Warning Sign

3. Accessible areas where insulation has been installed over the wiring must be posted with a warning sign (figure 4). In some jurisdictions, the sign must be in Spanish and English.

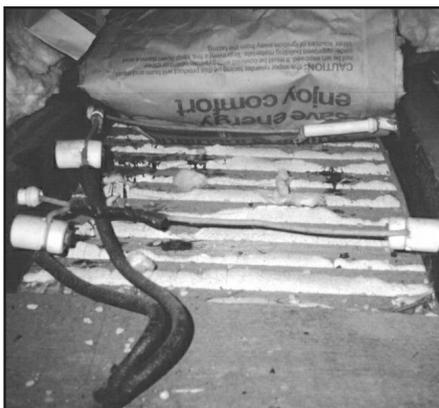
Figure 5 - Paper Faced Insulation

4. The insulation must be non-combustible. Paper-backed fiberglass (figure 5) would not qualify.
5. The insulation must be non-conductive. Foil-faced fiberglass (figure 6) would not qualify.

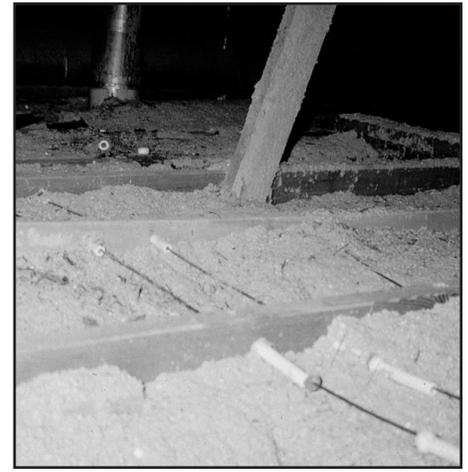
Figure 7 — Non-Flammable Insulation

insulation are treated with materials to inhibit flame spread. Some materials, including loose cellulose, have failed flame-spread tests after they were installed. Cellulose insulation (figure 7) is made of ground-up newsprint and a fireproofing chemical (usually a borate) mixed dry. It is possible the chemicals settle out of the insulation, reducing its fire resistance. Loose fiberglass does not have the same concerns regarding flammability.
